**Turbulence Structure and Bank Erosion Processes
in Dredged Channels**

A Thesis Submitted

Doctor of Philosophy

**Department of Civil Engineering
Indian Institute of Technology Guwahati
Guwahati – 781039, India**

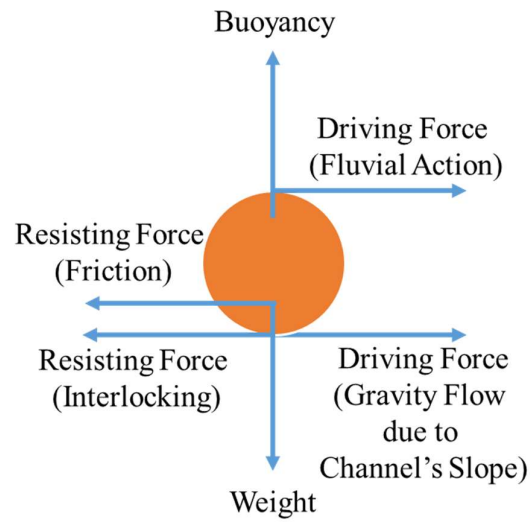
Figure 1.2: Resisting and Driving Forces on an Ideal Sediment Particle at the Riverbed

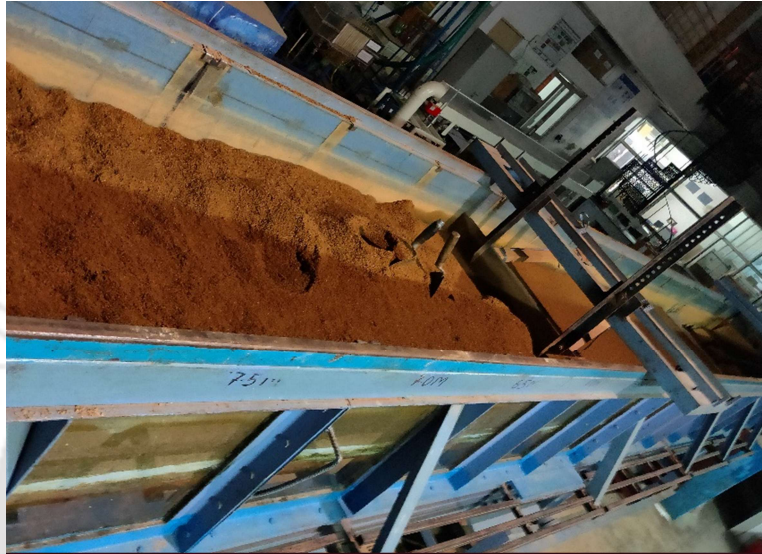
Figure 2.3: Channel Bed Preparation

The channel bed was prepared by placing the sand with a thickness greater than the required 0.15 m without any drops. The channel was flooded to achieve natural compaction. The water was drained, and the top of the sandbed was trimmed using the iron mould, as shown in Figure 2.3. The same steps were repeated to prepare the bed material for each experiment.

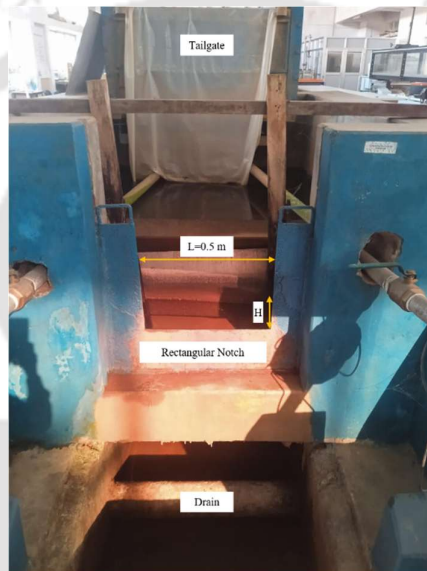
Figure 2.4: Rectangular Notch to Measure Flow Rate

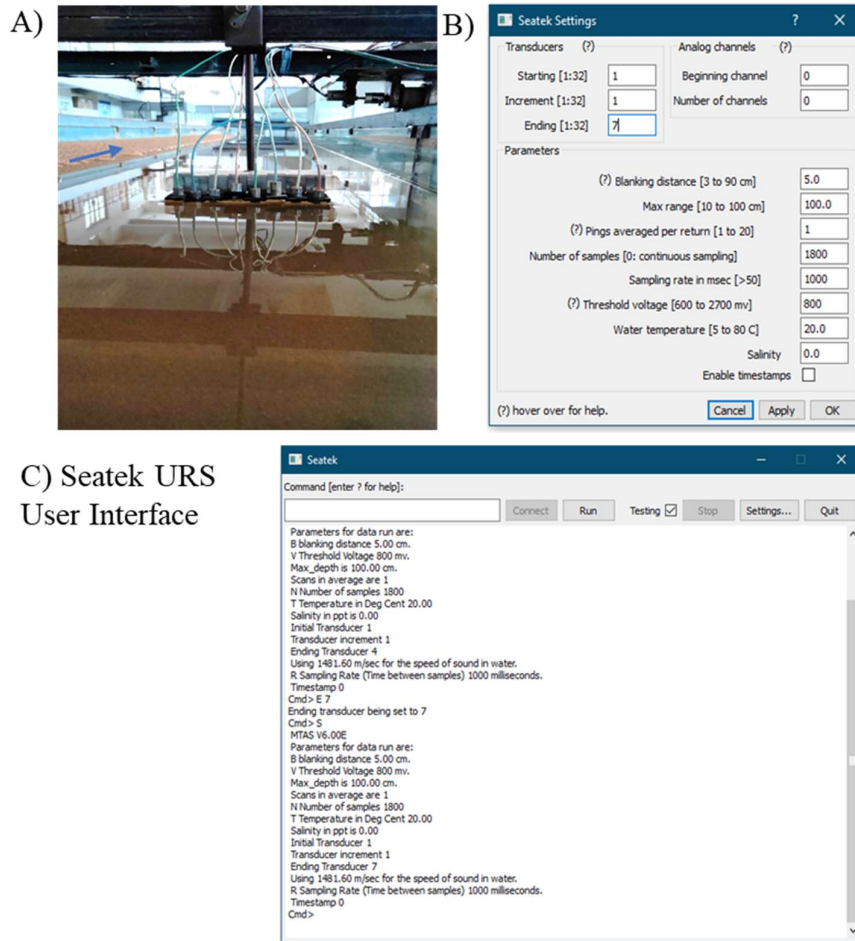
Figure 2.7: Ultrasonic Ranging System

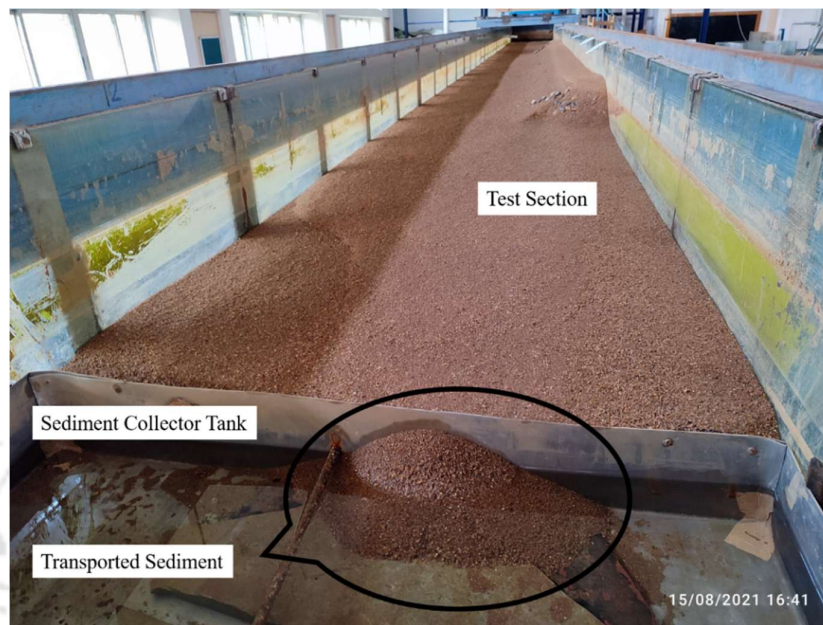
Figure 2.8: Sediment Collector Tank

The sediment collector tank is a container placed downstream of the test section. Its dimensions are 0.4 m in length, 1 m in width, and 0.15m in depth. The transporting sediment is trapped in this container, which is collected after the end of the experiments to compare the sediment transport for each case of the experiments. Figure 2.8 presents the collected sediment after an experimental run of 24 hours for the case of No Pit and a 31-degree riverbank slope. Keeping all other parameters the same except the changing cases of different types of pit helps

understand how the introduction of sandpit has changed the sediment transport capacity of the test section.

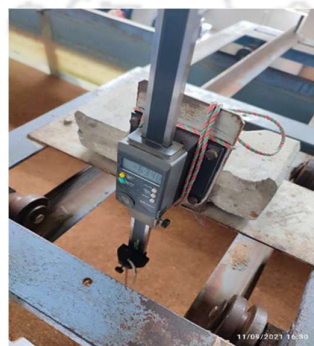
Figure 2.9: Digital Point Gauge

A digital point gauge (Figure 2.9) was used to facilitate the measurement of flow depth and to track the morphological changes after the flow of water had been stopped. This instrument helps track the final morphological profiles of the riverbank slope with a lateral distance of 2 cm between two readings, which is maintained using a steel ruler. The accuracy of the instrument for measuring depth was 0.1 mm.

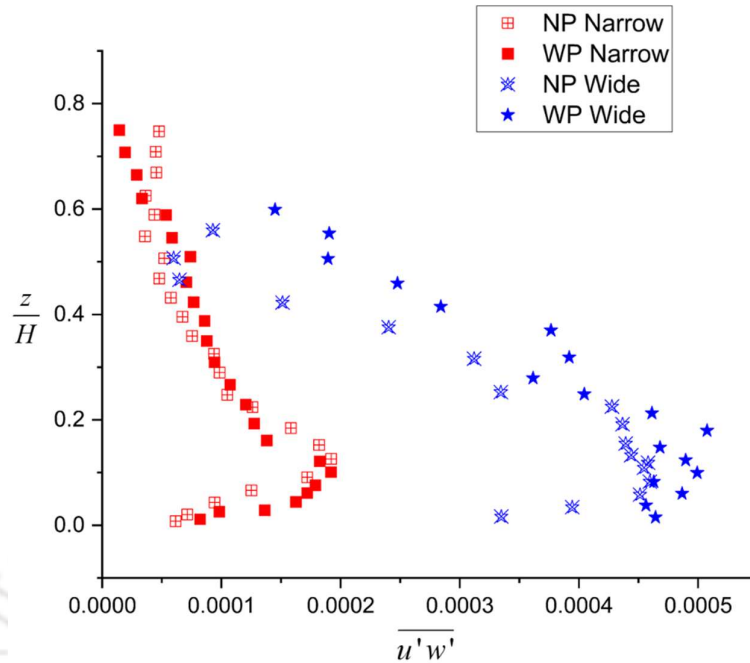
Figure 3.1: Streamwise Reynolds Shear Stress for Wide and Narrow Channels under Dredged Conditions. NP stands for No-pit and WP stands for with-pit. The pit is located upstream of the test section.

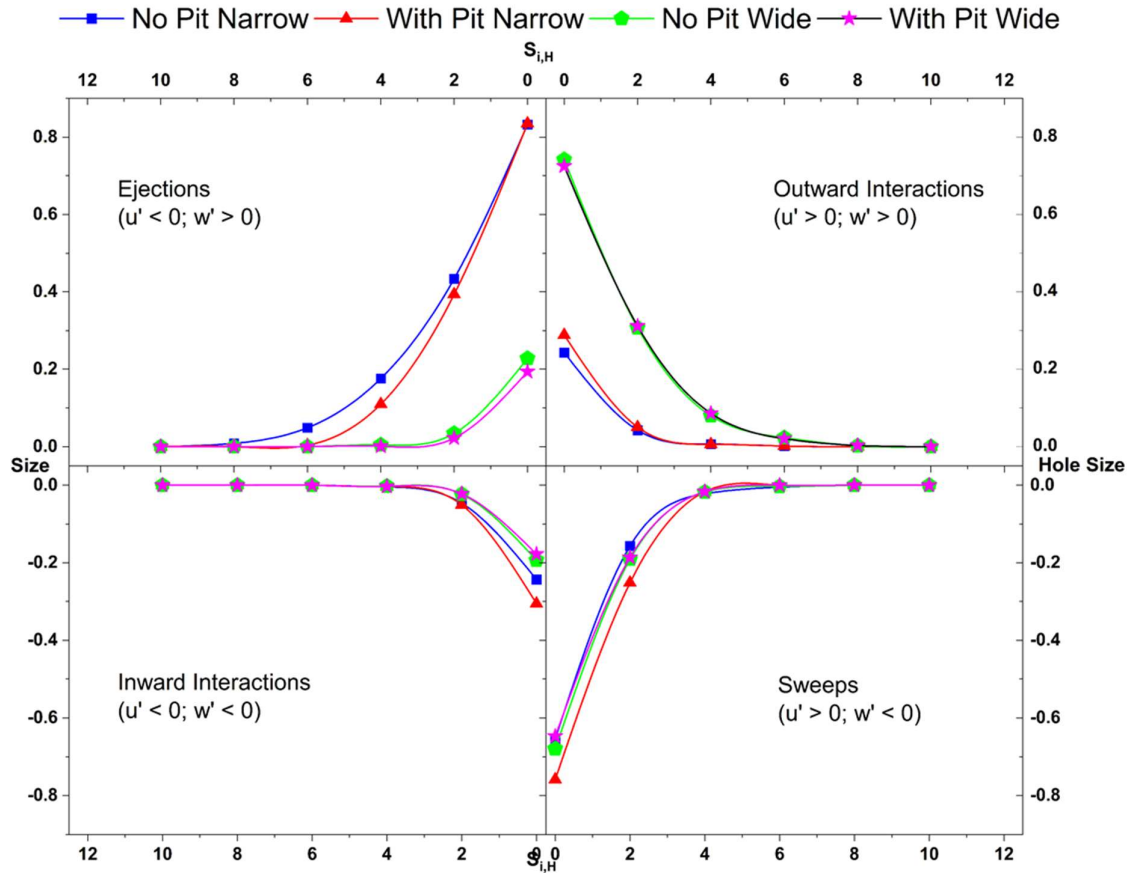
Figure 3.2: Quadrant Analysis at a depth of $z/H=0.2$ for the cases of Narrow and Wide Channels under Dredged Conditions

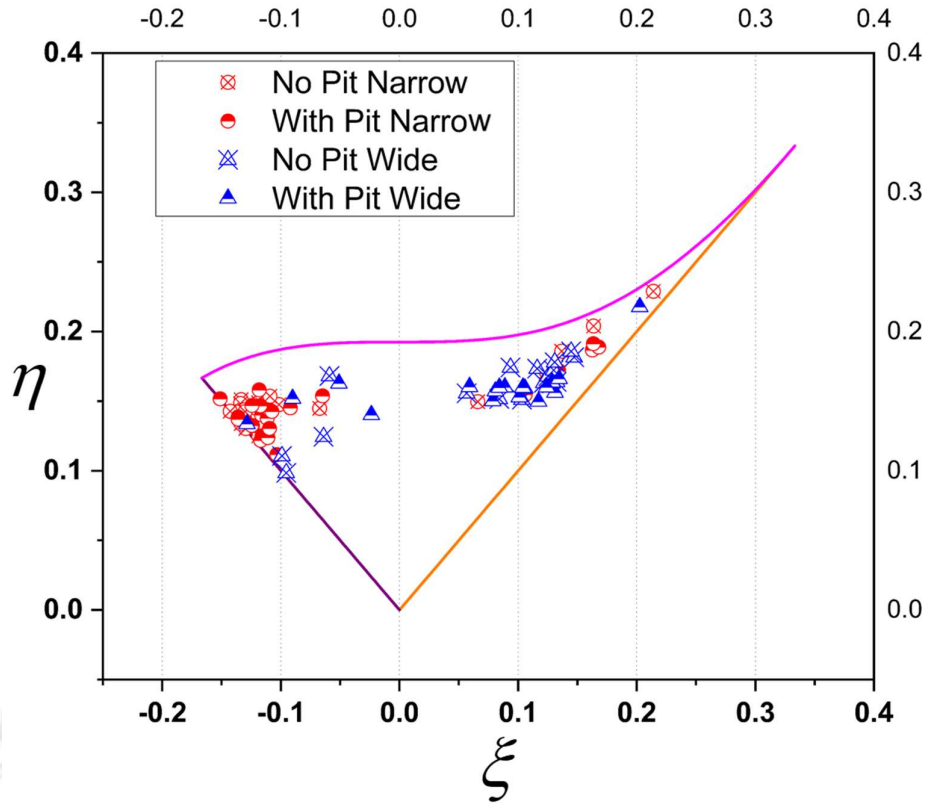
Figure 3.3: Anisotropy Invariant Map representing the relation between degree and nature of anisotropy for Narrow and Wide Channels under dredged conditions.

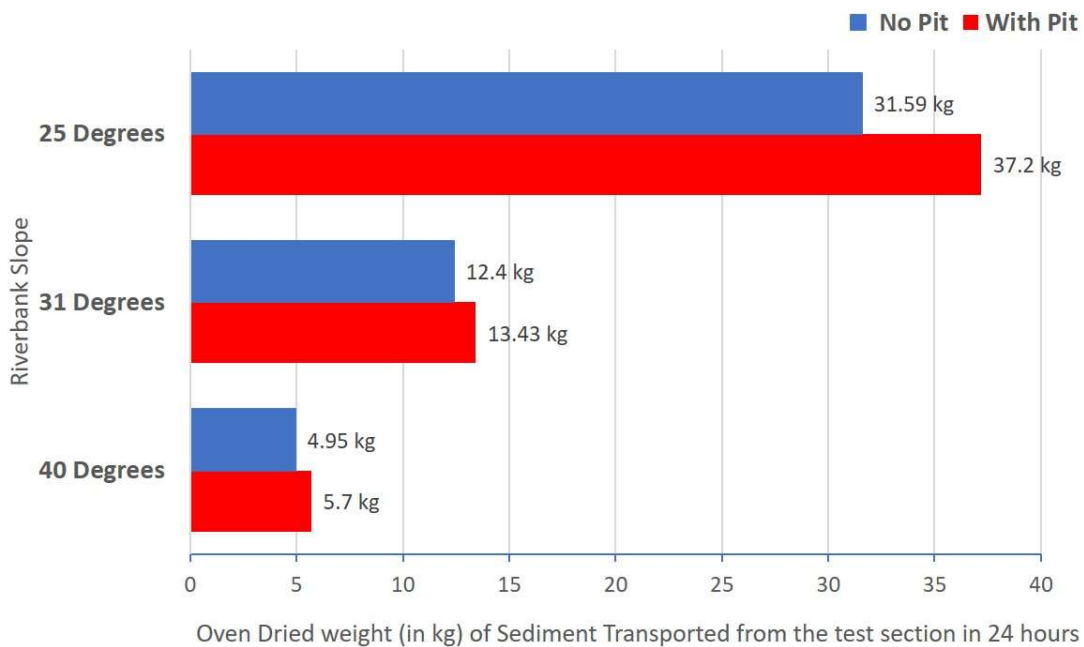
Figure 3.13: Sediment Transported through the Test Section in 24 Hours of the Experimental Run
