EXPERIMENTAL STUDY ON REHABILITATED RC BEAM-COLUMN CONNECTIONS UNDER CYCLIC LOADING

Thesis submitted

DOCTOR OF PHILOSOPHY

**CIVIL ENGINEERING DEPARTMENT
INDIAN INSTITUTE OF TECHNOLOGY GUWAHATI
GUWAHATI-781039, INDIA
NOVEMBER, 2011**

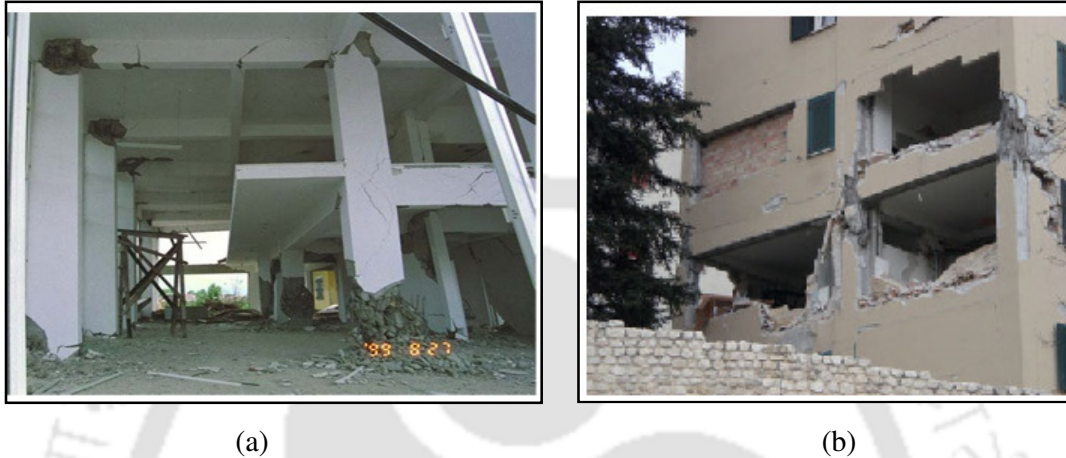
Fig.1.1 Distressed RC beam-column connections (a) during the 1999 Kocaeli, Turkey earthquake [Sezen *et al.*, 2000], (b) during 2009 L'Aquila Earthquake [Dr Anna Brignola, University of Genoa]

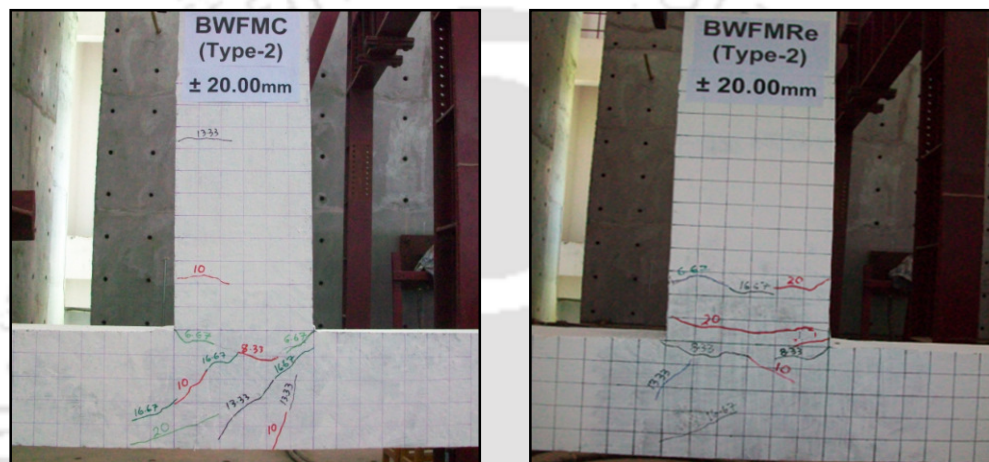
Fig. 3.9 Initial appearance of cracks for BWFM specimens under loading type-2

column joint interface and joint edges. The experiment was stopped at the same displacement level of ± 60 mm for BWFMc and ± 63.33 mm for BWFMRe. The displacement limits were kept same as those for testing under loading type-1. This was for facilitating comparative understanding of their behaviour. The ultimate load carrying capacity for BWFMc and BWFMRe specimens were found out to be 35.995 kN and 39.250 kN respectively.

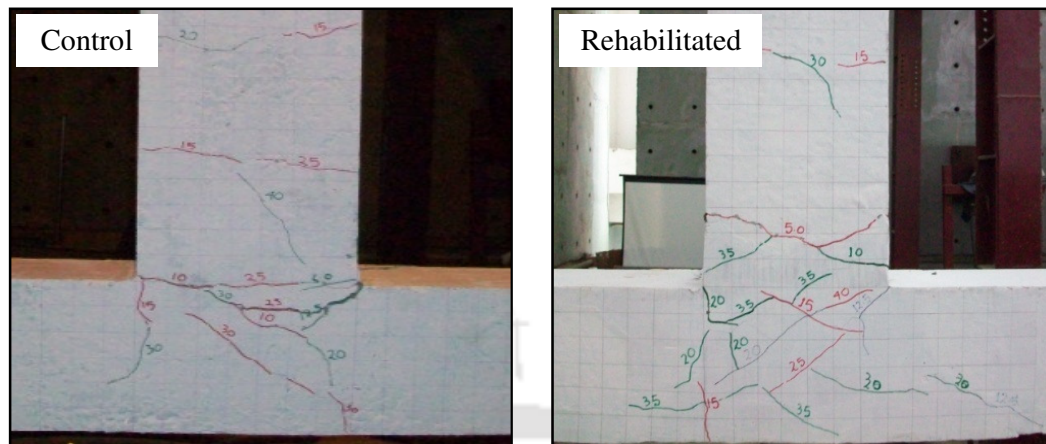
Fig. 4.4 Appearance of cracks for BWSL specimens under loading type-2 corresponding to peak load

at the joint interface became wider upto about 5 mm and alternate closing and opening of cracks became distinct at ± 50 mm displacement. Substantiate degradation in load carrying capacity was noticed at this level of excitation and the experiment for control specimen was finally stopped at ± 55 mm displacement. The ultimate load carrying capacity for BWSLC specimen was found to be 74.06 kN. Damage patterns in the rehabilitated specimens were quite similar to that developed in the control specimen, where the cracks were mostly concentrated at the joint interface. At a displacement of ± 45 mm, crushing of concrete at the joint interface started. The existing crack width at the joint interface widened to about 3 mm on reaching a displacement of ± 50 mm. Although rehabilitated specimen showed more numbers of crack on the joint region as compared to that in corresponding control specimen at the same displacement level, the rehabilitated specimen could be loaded upto the displacement of ± 60 mm. The maximum load carrying capacity for BWFLRe specimen was found out to be 80.98 kN. The displacement limits were kept same for both control and rehabilitated specimens when tested under loading type-1 and type-2. This was done for facilitating comparative understanding of their behaviour with respect to numbers of cycles of displacement history. At the end of the test, crack width of about 5 mm was observed at the joint interface in both control and rehabilitated specimens.

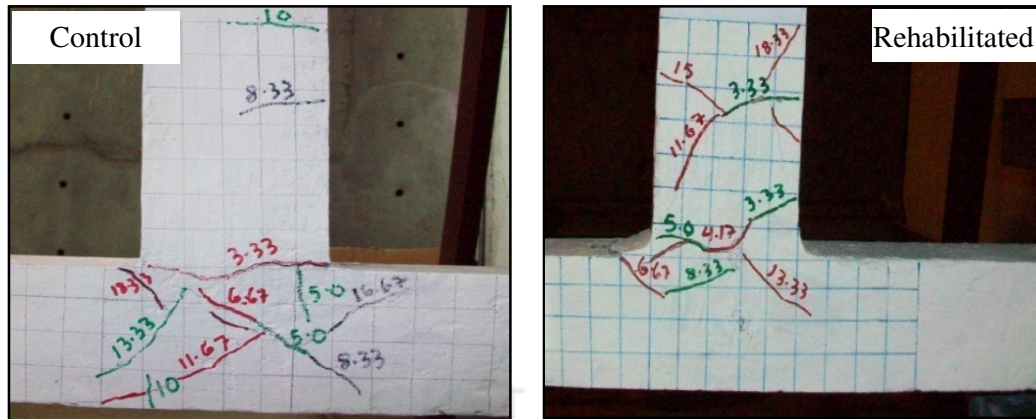
Fig. 4.16 Appearance of cracks for BWSS specimens under loading type-1 corresponding to peak load

The joint region for rehabilitated specimen was practically undamaged and instead severe cracking shifted to the beam part. This behaviour was similar to that of large and medium rehabilitated specimens under loading type-2. The over strength at the joint region imparted by the high strength epoxy could be the possible reason for this behaviour. Moreover, the initially developed shear cracks at the beam were also not repaired. Thus on further loading, these cracks widened up as the damaged was mostly concentrated on the beam part without transferring to the relatively stronger joint region.

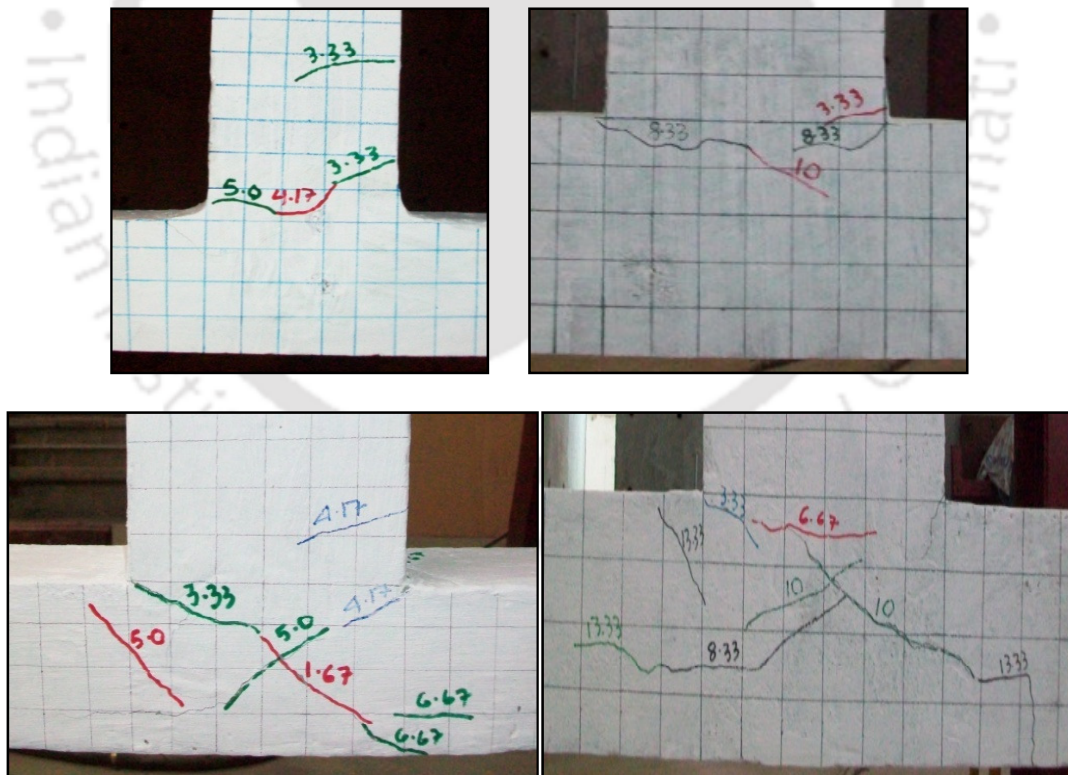
Fig. 8.1 Damage states in RM0 for a typical specimens
